# AUDENSHAW SCHOOL

## ACCESSIBILITY AUDIT ACTION PLAN

FEBRUARY 2024

*VERSION 2 – UPDATED MAY 2024*

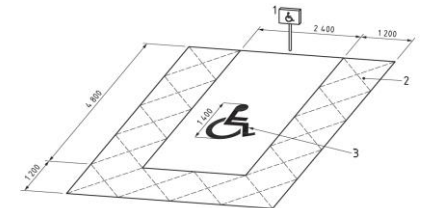
<p>2.2B</p>	<p>The accessible parking bay does not have a sign to the front as recommended by the BS8300.</p>	<p>Install a sign to the front of any accessible parking space.</p> <p>According to BS8300 - Sign should be present with its lower edge 1000 mm above the ground, to identify parking spaces, e.g. by snow or fallen leaves, with the words "Blue Badge holders only".</p>
